# A plausible trajectory for MH370<sup>1</sup>

# **MH370: An Operational study of a start to end Piloted Trajectory A new search area**

Jean-Luc Marchand, Philippe Gasser, Michel Delarche & Jean-Marc Garot  
*ATM - Air Traffic Management Experts*

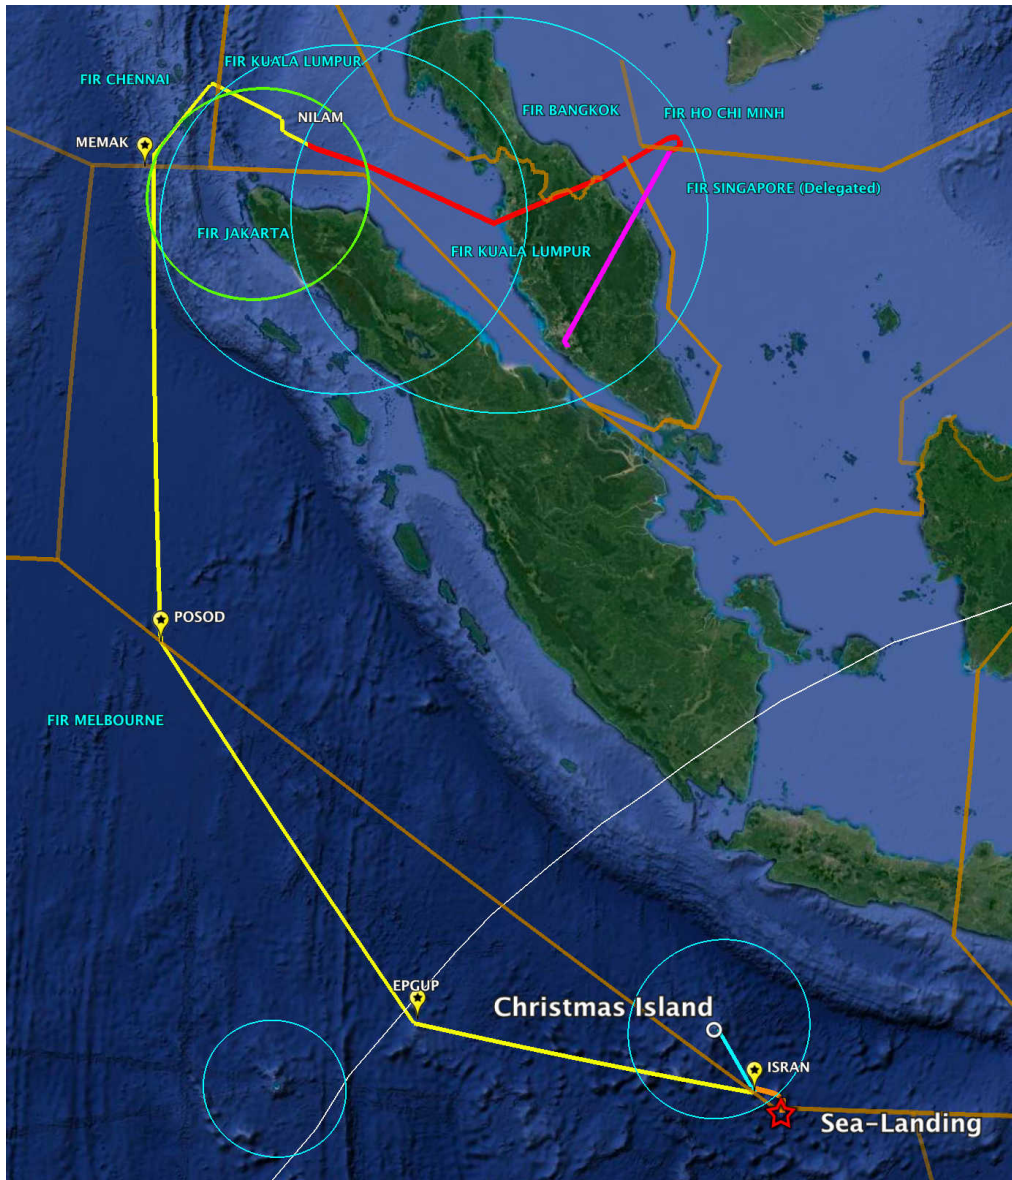
Figure 1:  
The five parts of the Piloted Trajectory  
and the FIR limits and the radar ranges

Figure 1 illustrates the planned and actual paths of the flight with the radar ranges at the corresponding altitude of the aircraft when it was in their vicinity. In particular, the light blue segment was planned for a safe landing at Christmas Island while the orange path leads to the location of the probable emergency ditching.

These 24 keys events are presented along the 5 parts of the trajectory shown in different colours in Figure 1.

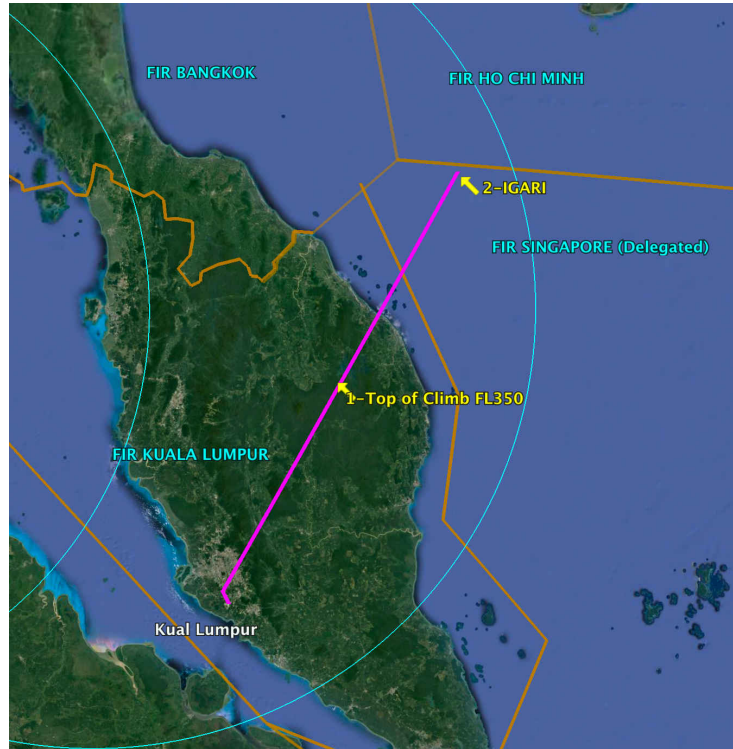
Figure 2:  
The location of the key Events: Take-off, 1 and 2.

Figure 2 illustrates Part 1 of the trajectory i.e. flown according to the filed flight plan until waypoint IGARI.

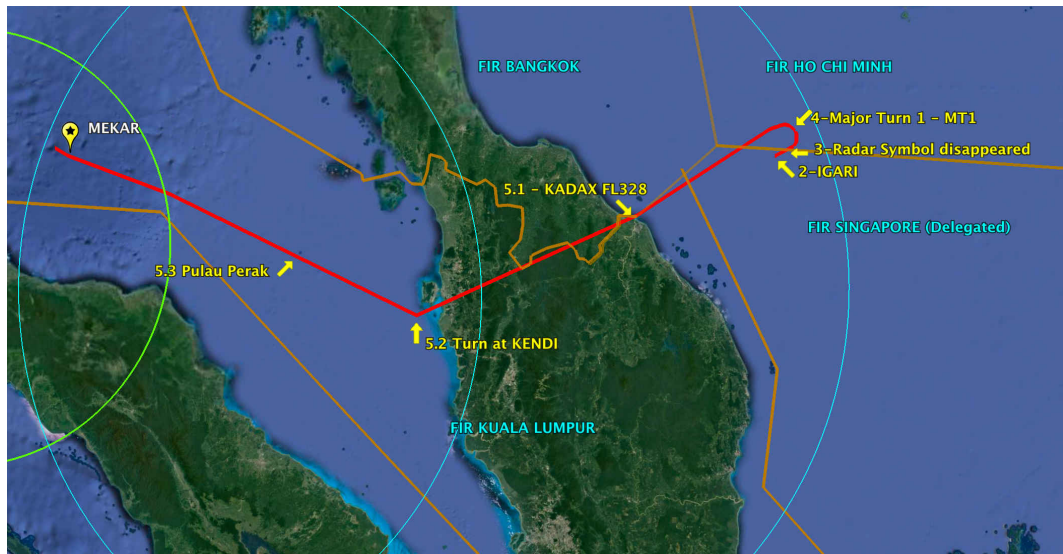
Figure 3:  
The location of the key Events 3 to 5.

Figure 3 illustrates Part 2 from the SSR symbol disappearance to MEKAR.

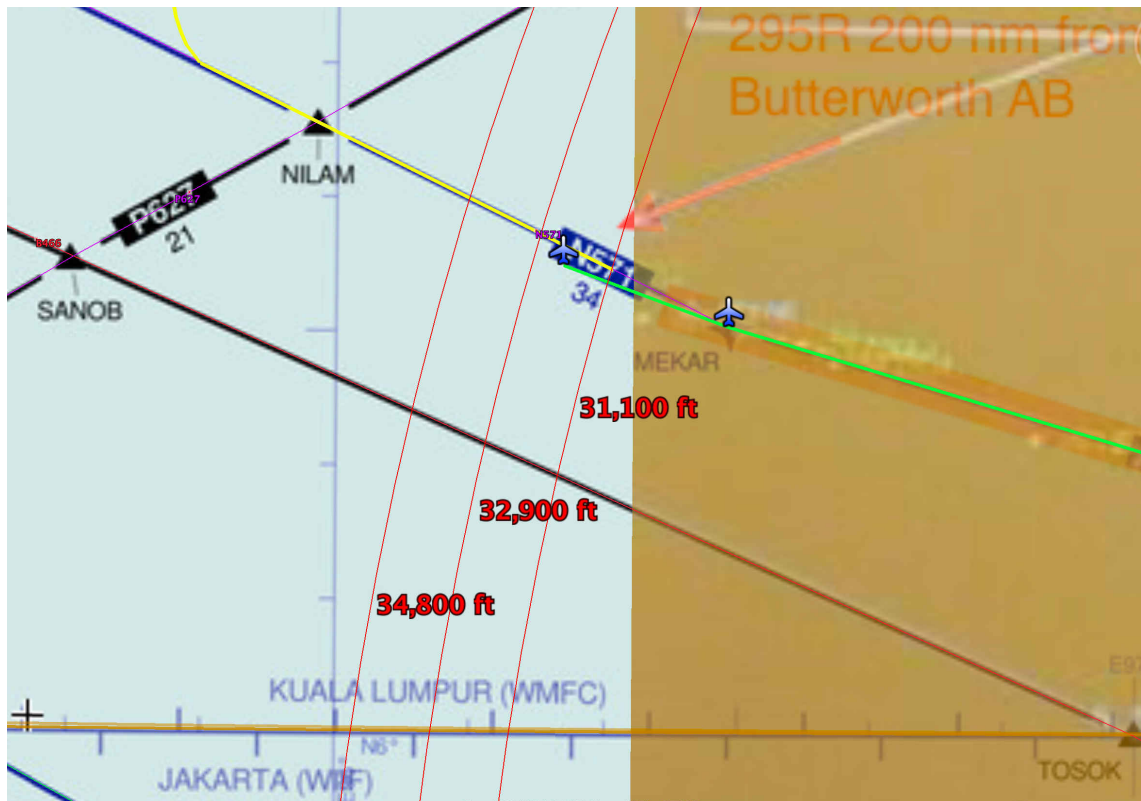
Figure 5:

Position of the aircraft at 18:22:12 versus the Penang radar range coverage limits at 31,100, 32,900 and 34,800ft

The commonly agreed coordinates of the LRSP are ~(6.5770N, 96.3423E) which, according to our computation of the radar range capacity, suggest an even lower exit level closer to 31,200ft.

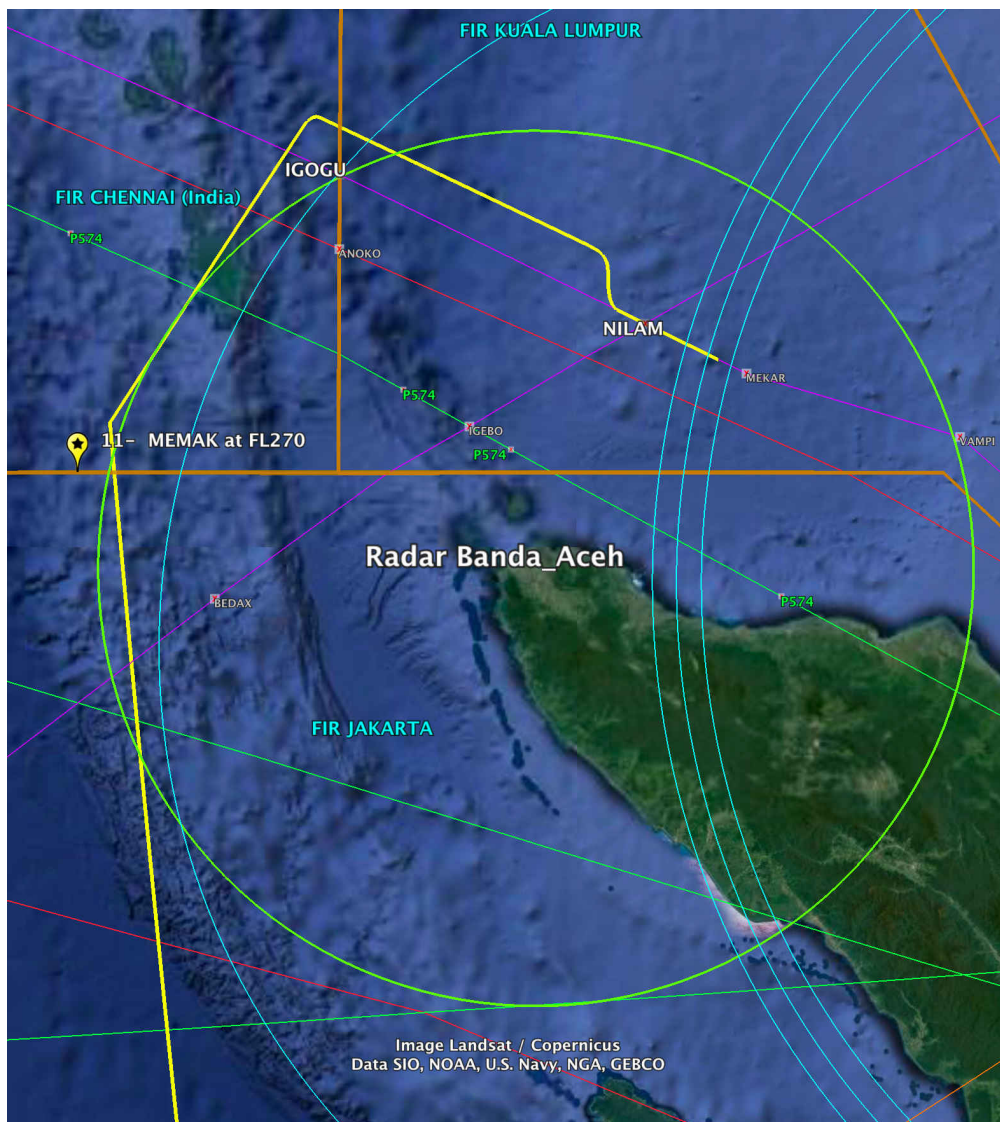
*Figure 6:*  
*The path MT-2 to MEMAK stays out of range of Banda Aceh SSR radar.*  
*The green circle is the maximum range at FL270.*  
*The yellow track is the aircraft path since the offset manoeuvre.*

Note: The path of the aircraft was within the coverage of the military Sabang Radar. It is intriguing that there is no trace of it. On the other end, there must have been many spots on the screen at that time and the MH370 was just one amongst many others. In addition, the MT-2 manoeuvre of the aircraft may have not been captured as it occurred within a short lapse of time (less than 1:30 min).

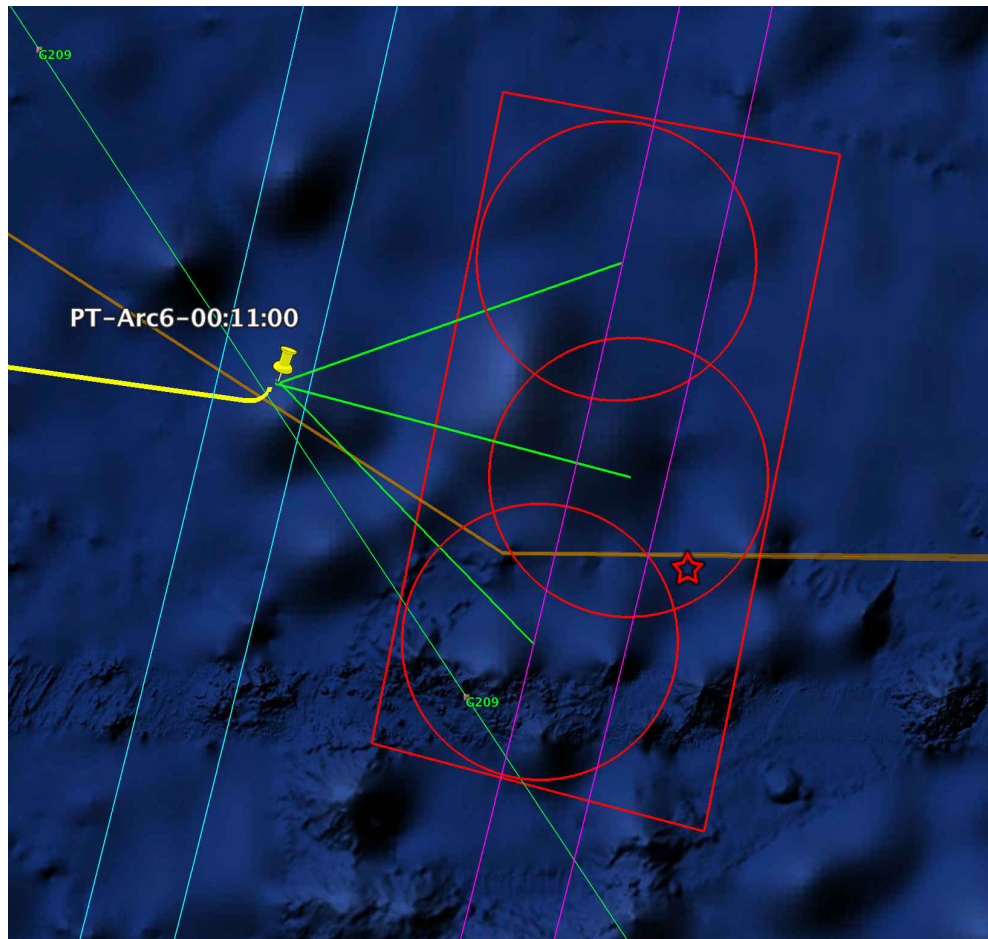
Figure 10:  
Identification of the new search zone

Consequently using three specific points at the flown distance of 42NM (green segments in Figure 10) and using the gliding distance from there via circles, this defines a maximal search zone as depicted in Figure 10. This is a kind of trapezoidal zone which maximal width is 40NM and maximal length is 80NM. The area is around 10 000 km<sup>2</sup>.

Considering the estimated flight level at Arc-7 crossing i.e. 5,000ft and the lift-to-drag ratio of the B772 (~17 to 18), the probable ditching point location is about 16NM away from Arc-7. This means at (-12.025687S, 107.363234E) or (12°2'32"S, 107°22'48"E) if one assumes a constant heading at 135°.

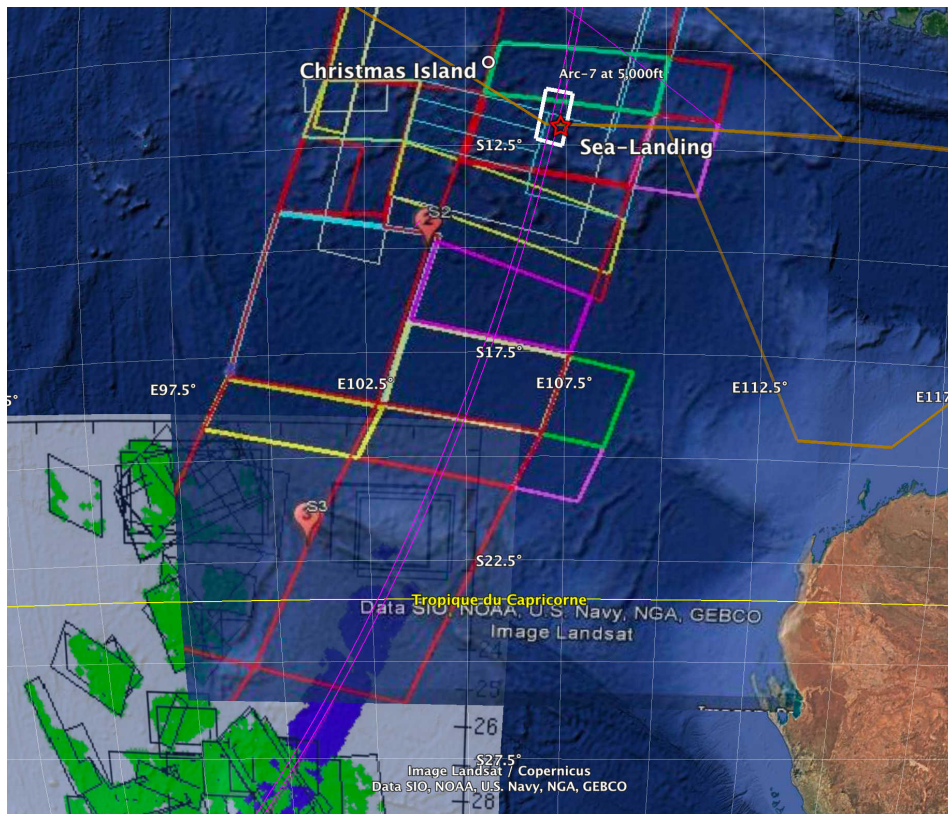
Figure 11:

*The identified zone for the proposed new underwater search (in white)*

The proposed search area has also never been searched underwater.

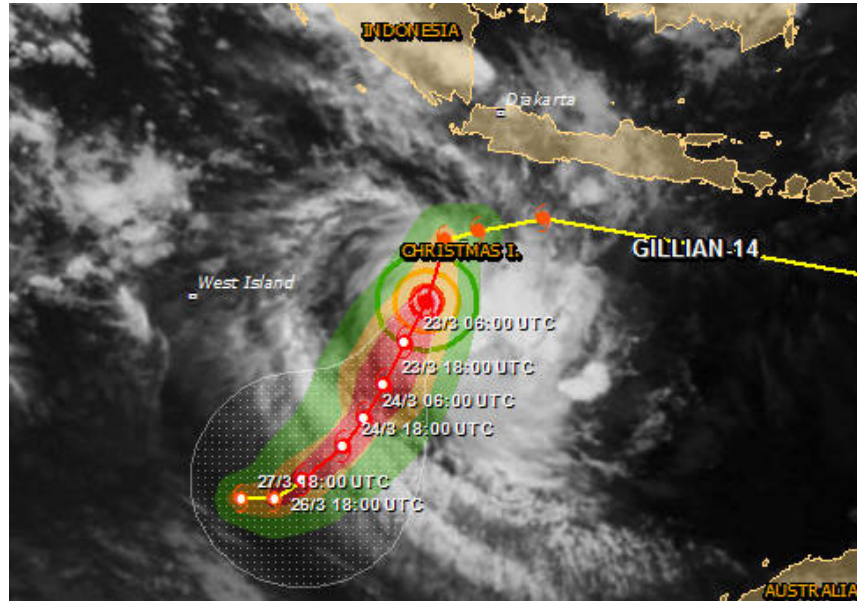
Figure 12:  
Hurricane Gillian path.

Hurricane Gillian [36] started on 8<sup>th</sup> March in the Gulf of Carpentaria offshore northern Australia and overflowed Christmas Island on 22<sup>nd</sup> March (cf. Figure 12). Finally Gillian dissolved on 26<sup>th</sup> March at location ~(-21.0S, 103.5E). That is about 596 nautical miles west of Learmonth in Australia.

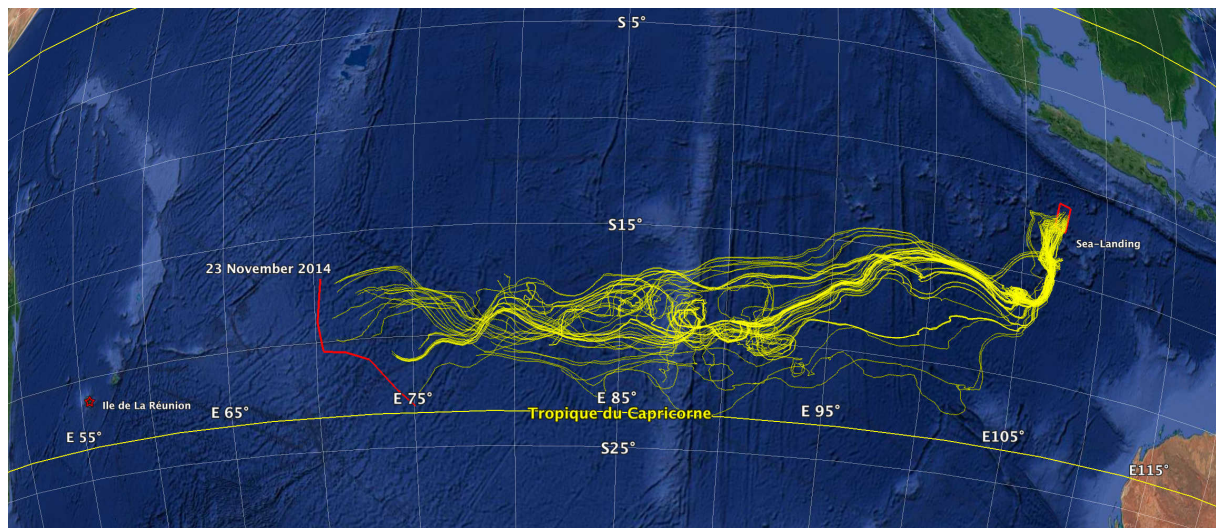
Figure 13:  
Debris drift from the vicinity of the identified sea-landing zone

The drift analysis has been made for the debris with the same characteristics as the flaperon and in particular the specific additional angle of the drift due to the emerged part pushed by the wind.

Results of the simulations presented in Figure 13 confirm that taking into account the impact of Gillian supports the hypothesis that debris could have drifted from the vicinity of the identified sea-landing point towards actual locations where debris have been found in 2015.

During the 8 days of strong wind and waves, the debris would have most probably drifted southwards pushed by Gillian. It is estimated that they reached a sufficiently low latitude ( $\sim 16^{\circ}\text{S}$  /  $18^{\circ}\text{S}$ ) to drift westwards in the Indian Ocean eventually. Figure 13 illustrates the results of the rough estimation produced by the CAT until 23<sup>rd</sup> November 2014.

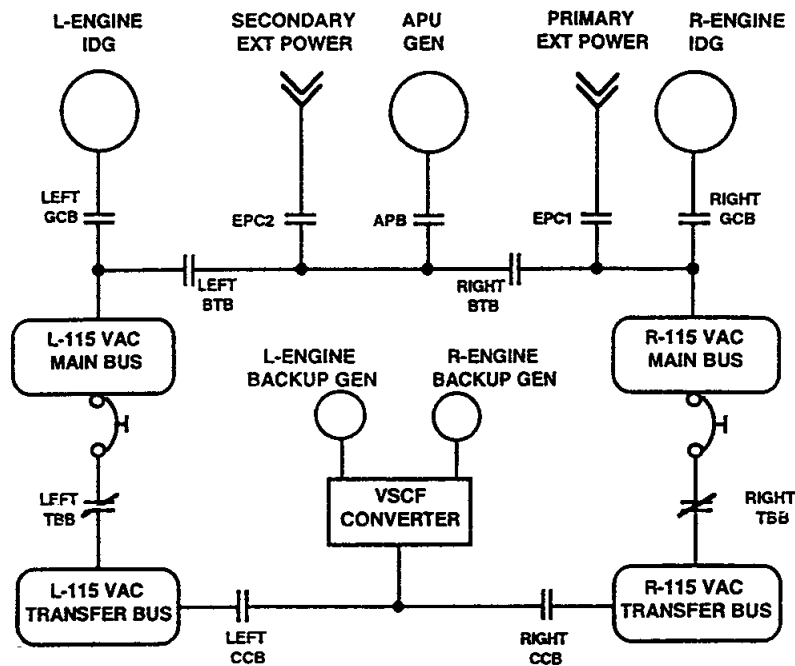
Fig. 1. Main and AC Backup Power

The two following diagrams (borrowed from [43]) show the overall architecture of the electric generation and distribution system and the control switches available in the cockpit.

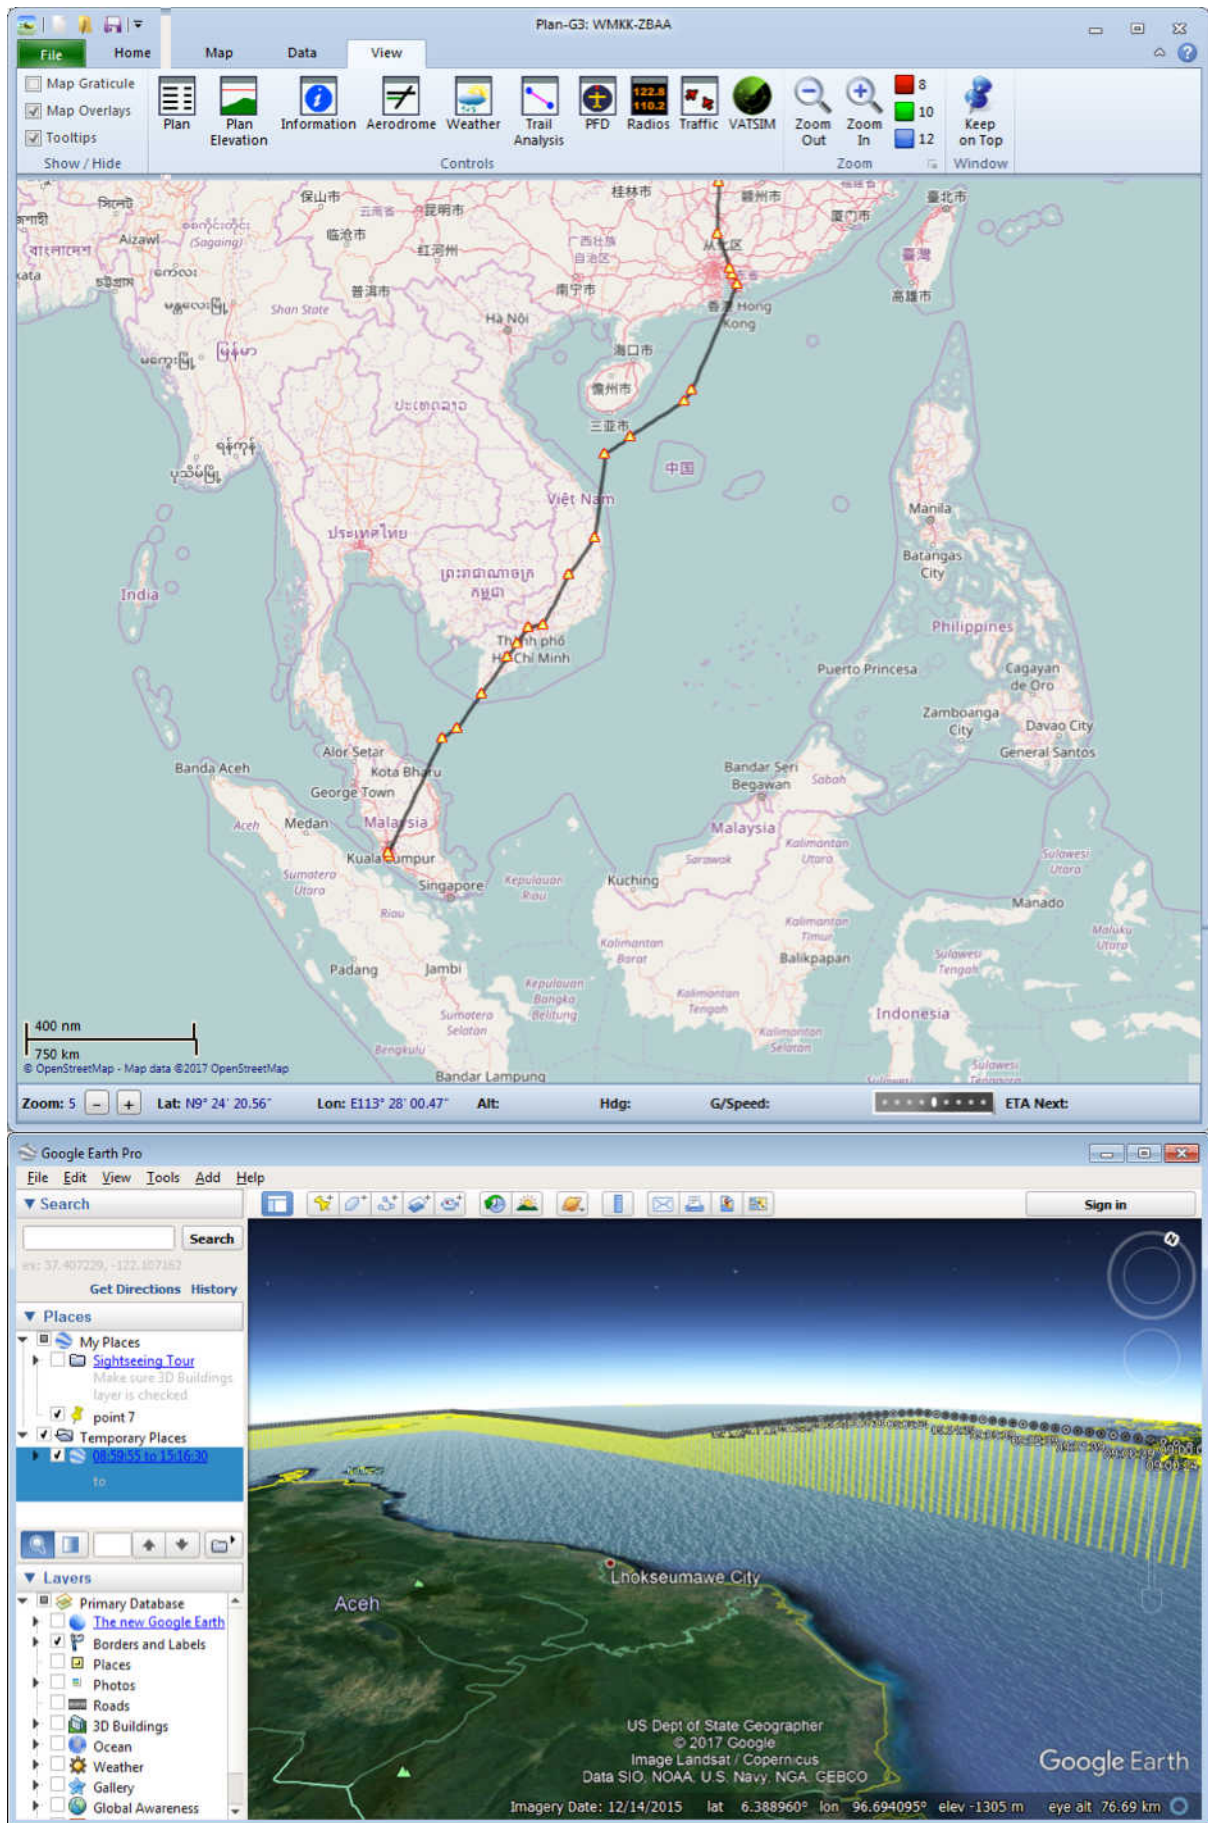
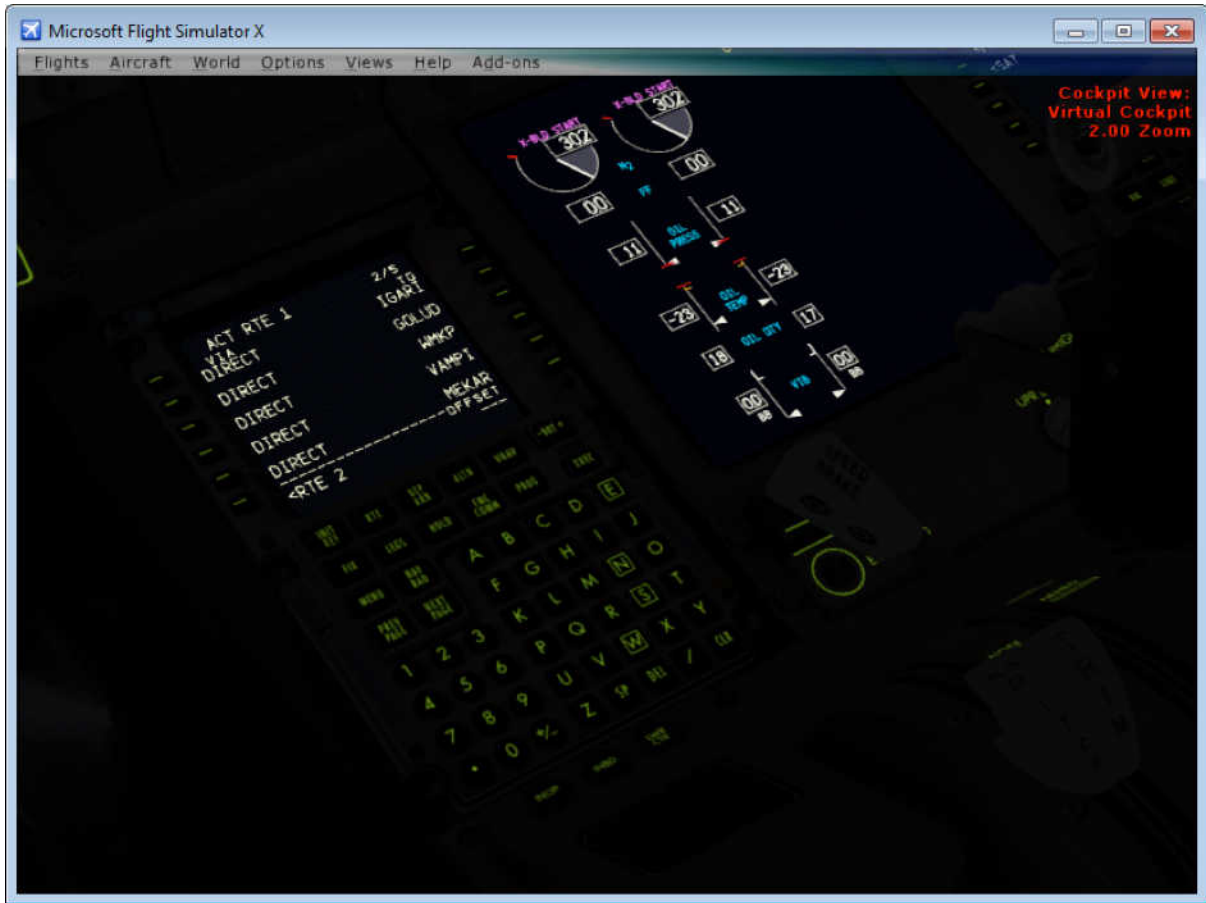
- **The plans and simulations tool** inserts in a table trajectory data from trajectory information typed-in manually or copy-pasted from external tools; it recognises latitude/longitude (deg/min/sec, deg/dec), alt (ft) waypoints and airports ICAO codes and translates them in coordinates (deg/dec) . All of this data can be updated after translation and the plan can be updated and other points/segments can be inserted at a later stage. AIRAC 1501 data comes from Navigraph Data included in the PMDG 777 Model which has been used in our simulations. They have been inserted in the Microsoft Flight Simulator X (FSX) environment. Data can be exported in different formats: Google Earth (GE) .kml files, FSX .pln file and basic PMDG .rte file in order, first to display the 3D trajectory in GE (or in 2 D in Plan-G or FSX) and then they can be loaded as flight plans into aircraft flight management system (FMS) (for PMDG and other FSX compatible models). Each plan can be associated to one or more simulations which contain logs of key parameters (position, speed, direction, altitude, wind speed and direction...) . These data are the results of simulations performed using FSX models and recorded with Tiny Flight Tracker. These logs are imported and combined and provide a trace of how the simulation was conducted. A start time can be specified to derive a time-stamp for each sample according to this initial value.

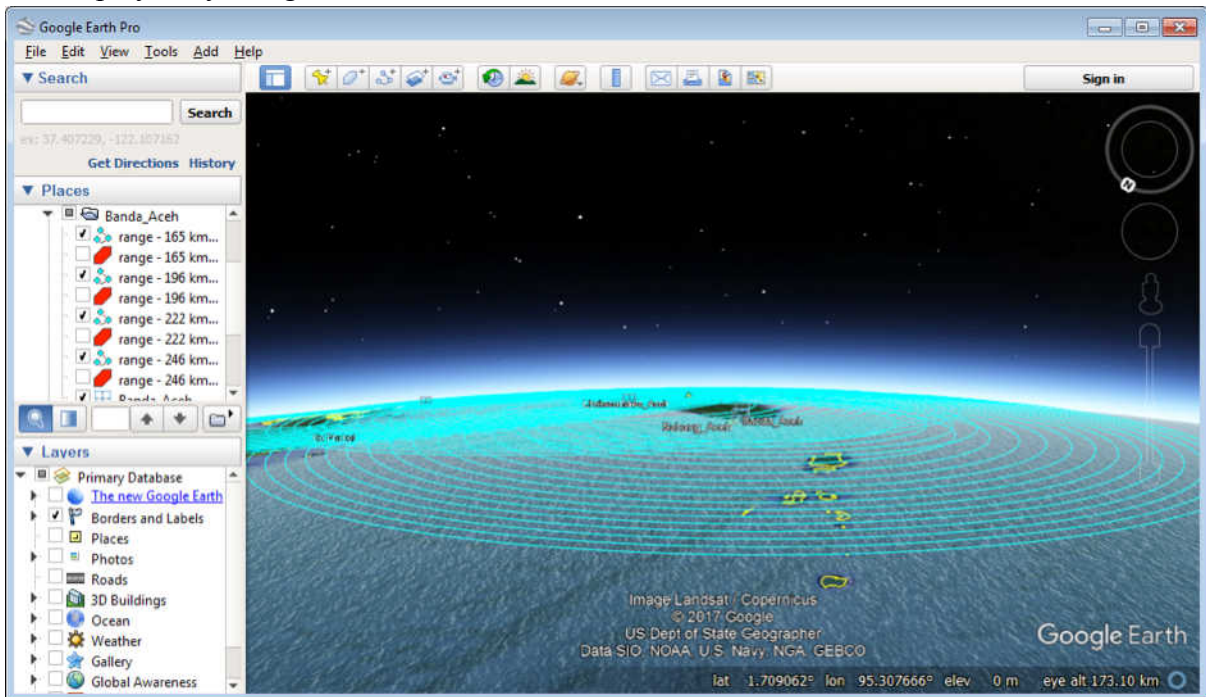
- **The radars generator tool** generates kml files to display 3D radar coverage in GE. Data sources have been fetched from the ICAO GIS site (MH 370 story) and data provided by the MH370 Independent Group. Ranges for different altitudes are calculated and can be selected and displayed by using standard GE functionalities

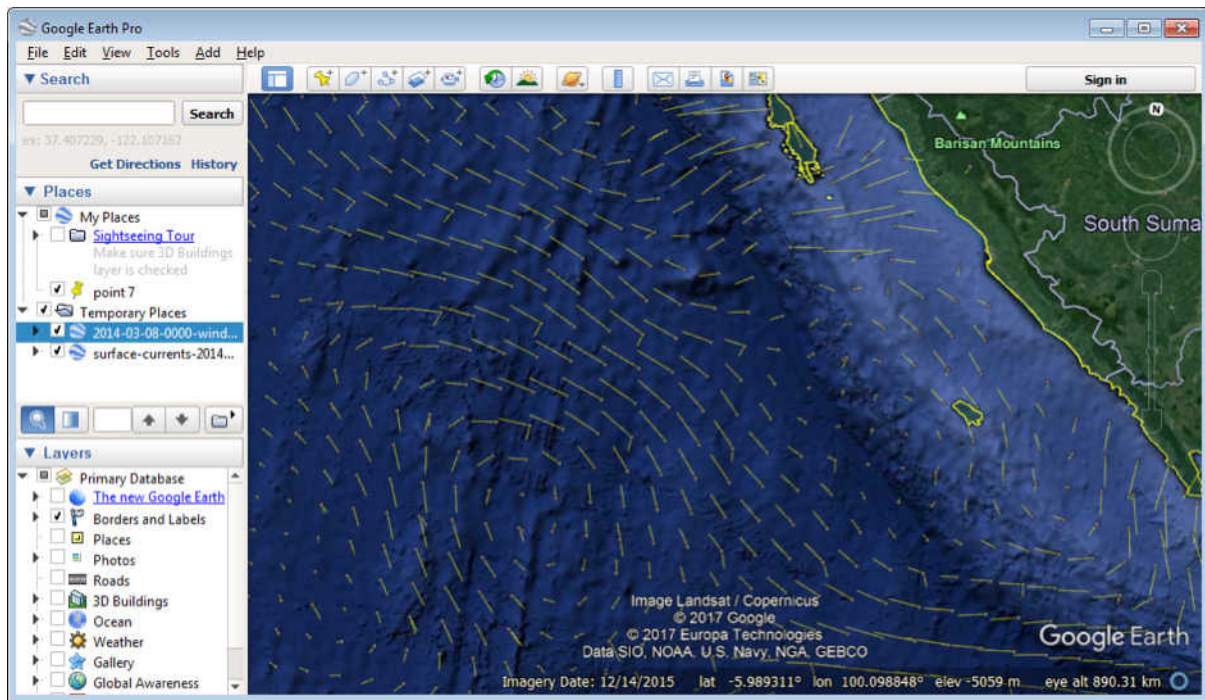
- **The weather data transformer** downloads historical surface currents and wind data from Earth Nullschool (EN). That information has been produced by the Global Forecast System (GFS)

NOAA and Earth and Space Research Institute (ocean surface current analyses (OSCAR) derived from satellite data) and stored by EN. Some downloaded data had to be decompressed before transformations. The period considered is from the 7th of March 2014 until the 23<sup>rd</sup> of November 2014 for the wind and the current at surface level. From the 7<sup>th</sup> of March 2014 3pm to 8th of March 2014 3am addition wind information at isobaric 850hPa, 700hPa, 500hPa, 2050 and 1000hPa roughly and respectively equals to FL004, FL048, FL099, FL183 and FL340 because the barometric pressure was close the standard 1013hPa at sea level the day of the disappearance (source EN). Samples have been collected by the GFS and OSCAR each 3 hours for the wind and each 5 days for the current. Standard weather GRID (1 degree for wind and 1/3 degree for current) files have been converted and data have been used to populate many MS Access tables.

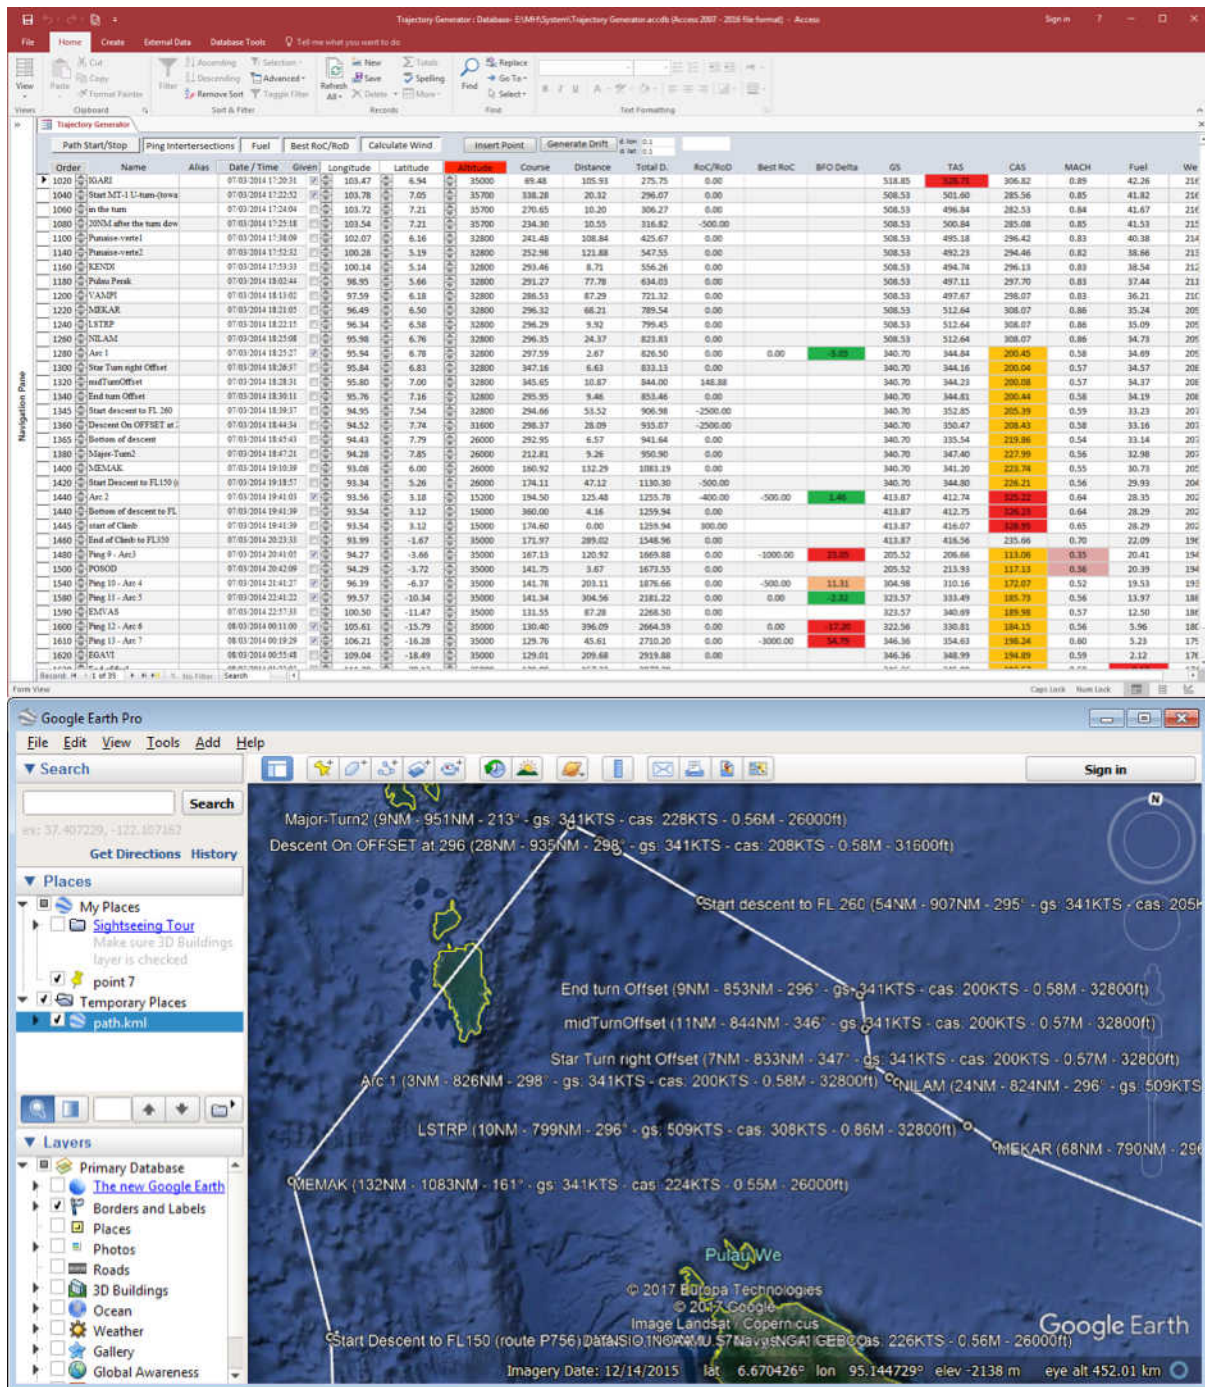
- **The trajectory calculator** yields a 4D trajectory (time constraint at specific points). Calculations include:
  - at a non-arc-crossing point: time (if not given), distance (and total distance from the starting point), course, ground speed, true airspeed (TAS) and direction (using weather data – see above – and 3D linear interpolation), calibrated airspeed (CAS), Mach number, equivalent airspeed EAS) (for delta ISA=13; mean in the latitude under consideration – source EN)

- at arc-crossing points it calculates the 3D location of the intersection of a segment of flight path and the sphere having a radius equivalent at the corresponding BTO and the centre point located at the satellite position at this time. The altitude and Rate of Climb (RoC) or Descent (RoD) is calculated as a function of the two segment extremities. This calculation is based on the model developed by Yapp FF and on the longitude calculator developed by Barry Martin & Geoff Hyman. It calculates the best Rate of Climb or Descent as well (between -7 000 ft/min and +7 000 ft/min per step of 500ft) for the aircraft located on a specific arc and having a fixed speed and heading in order to get the best BFO at this position for this range of rates.

- an interactive interface enables the user to dynamically modify and update the trajectory either by typing (or copy/pasting) data directly in the form or using the mouse and/or buttons. A kml file is generated by the tool at regular interval and is periodically read by GE which display trajectory changes on the map. Moreover data which are outside the aircraft flying envelop are highlighted.

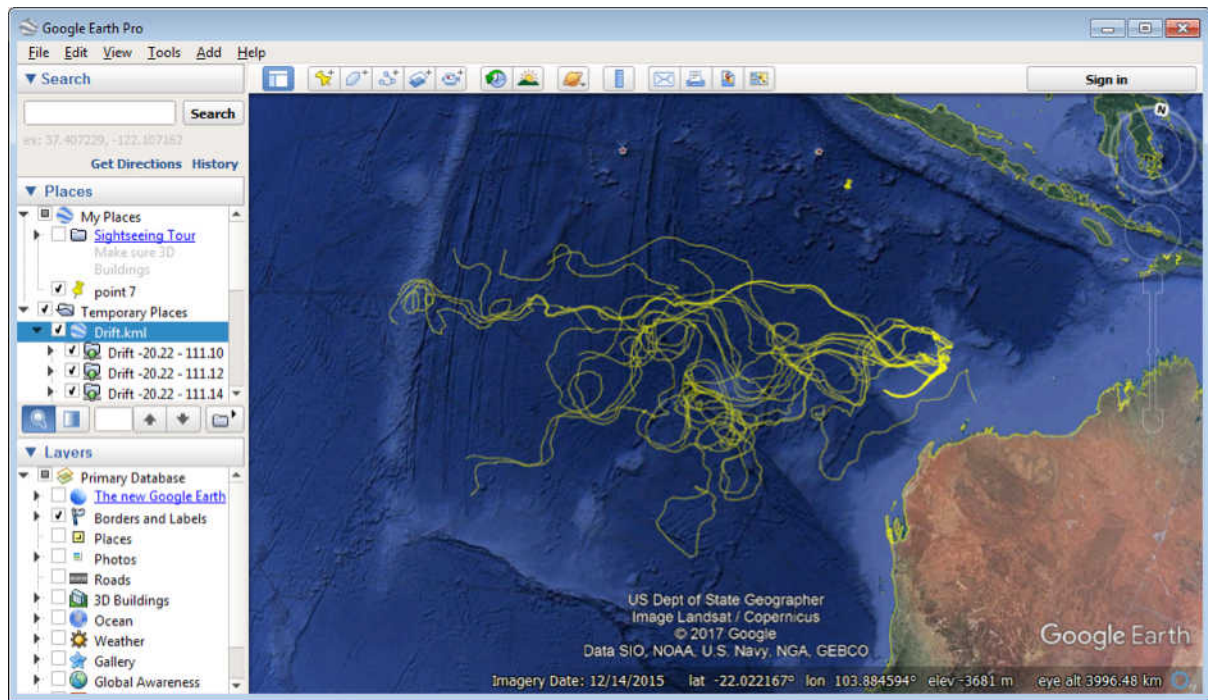
• **The Drift Calculator** uses surface current and surface wind (source EN) as inputs to calculate the drift of the debris based on latest CSIRO report which specify that the flaperon drifted with the surface current plus the surface wind with 16 degree orientation to the right and an additional speed of 0.1m/s in the wind direction. This calculation is done using a linear interpolation of weather data with for the wind a 1 degree grid and delay of 3hours between samples and for the current a 1/3 degree grid and a 5 days period of time between samples. It starts the calculation from location of the last point of the trajectory defined in the trajectory calculator tool. It runs the calculation using samples from the 8<sup>th</sup> of March 2014 until the 23rd of November 2014. It uses linear interpolation to calculate values from one point to another. The zone is specified at the beginning and 121 paths are calculated from this area.

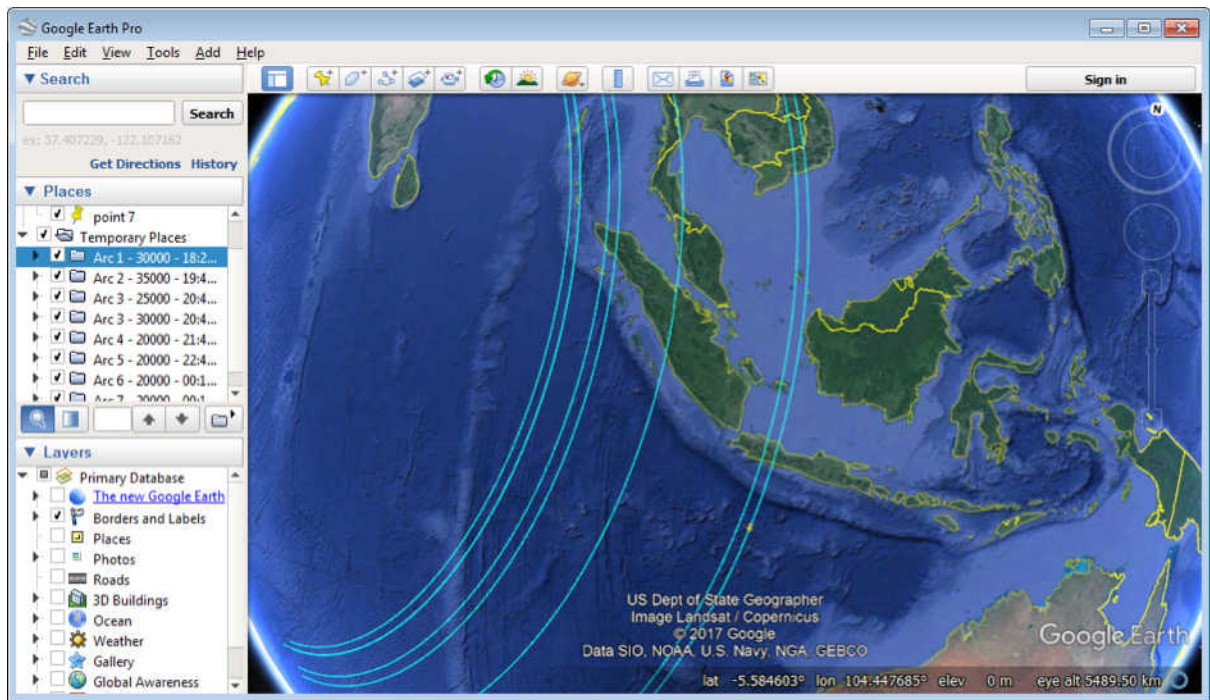
- **The arc generator** is based on the longitude calculator developed by Barry Martin & Geoff Hyman. It generates arcs from BTO values and altitude; Arcs are displayed in GE
